## **Eleventh Month Warranty Maintenance Inspection Report**

### **HAZARDOUS MINE OPENING PROJECT; PHASE 25, PROJECT 28**

**DSL-AMRB 90-022**

**September 1992**

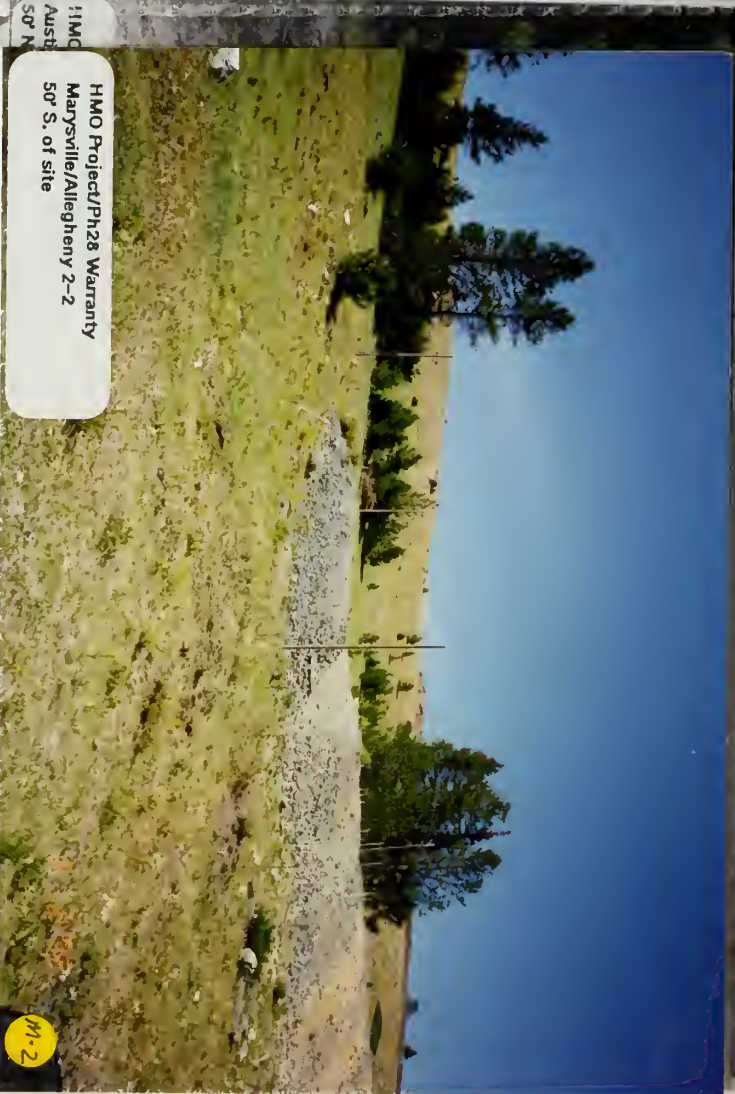
HMO Project/Ph28 Warranty  
Marysville/Allegheny 2-2  
50' S. of site

PA #	SITE NAME	NO.	CLOSURE	CONDITION	PHOTO NO.	COMMENTS
25-184	Albion	1-1	Sign	Good	M-1	
25-060	Allegheny	2-2	Del. Posts	Good	M-2	Need hazard signs installed.
25-062	Ample/Hickey	8-3	32'x 36' Grate	Good	M-3	
		8-4	Fence	Good	M-4	
25-116	Big Ox	5-11	Culvert	Good	M-5	No vegetation.
		5-12	16' x 24' Grate	Good	M-62	
		5-13	Cable Net	Good	M-6	
		5-14	Culvert	Good	M-7	No vegetation.
25-127	Black Douglas	7-15	Fence	Good	M-8	
25-120	Blackhawk/Janette	33-16	Backfill	Good	M-9	Excellent vegetation
		33-17	Backfill	Good	M-10	Fair vegetation with some weeds. Currently being grazed
		33-97	Backfill	Good	M-11	Poor vegetation with weeds. Currently being grazed
		33-98	Backfill	Good	M-12	Good vegetation.
25-076	Drumlummon	10-19	16' x 16' Grate	Good	M-13	Excellent vegetation. Some knapweed in area
		10-20	8' x 16' Grate	Good	M-14	Excellent vegetation.
		10-26 10-27 10-28	Fence	Good	M-15	
		10-29 10-31	Fence	Good	M-16	
		10-30	Fence	Good	M-17

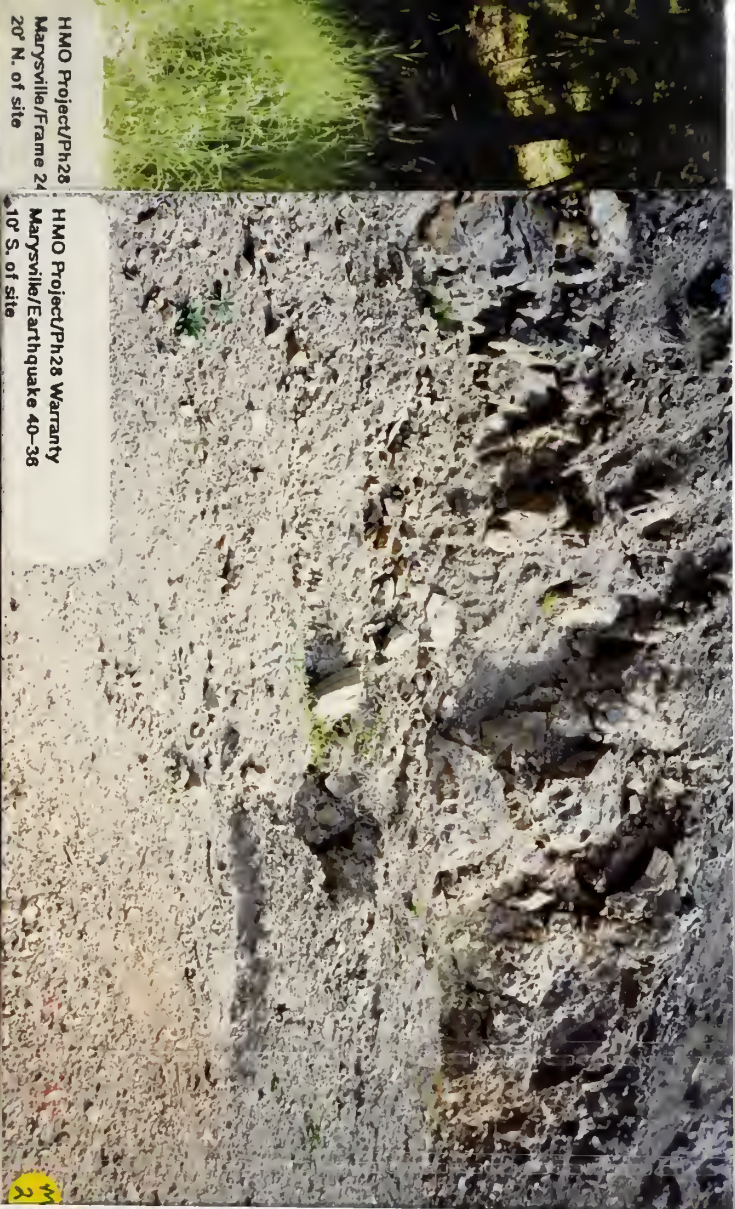
HMO Project/Ph28 Warranty  
Marysville/Earthquake 40-36  
10' S. of site

PA #	SITE NAME	NO.	CLOSURE	CONDITION	PHOTO NO.	COMMENTS
25-077	Earthquake	40-36	Backfill	Minor Sub.	M-21	Monitor subsidence. No vegetation as site is in roadway.
25-078	Emma Miller	11-37	Fence	Good	M-22	
25-015	Empire	12-38	Adit Gate	Good	M-23	
		12-43	Adit Gate	Vandalized	M-24	Mine timbers have been vandalized and access gained around adit gate.
25-173	Erie	13-39	Backfill	Good	M-25	No vegetation. Site backfilled with rock.
		13-40	Backfill	Good	M-26	No vegetation. Site backfilled with rock.
		13-41	Backfill	Good	M-27	No vegetation. Site backfilled with rock.
25-134	Fraction	20-42	Fence	Good	M-28	
25-132	Frame	24-63	3' Culvert	Good	M-29	Excellent vegetation.
		24-64	4' Culvert	Good	M-30	Good vegetation.
25-126	Genesee	14-44	Fence	Good	M-31	
		14-45	Fence	Good	M-32 & 33	
		14-46	Fence	Good	M-34	
25-130	Griff	15-47	Fence	Good	M-35	
25-125	Kenawa	18-48	Fence	Good	M-36	
		18-49	24' x 24' Grate	Good	M-37	Fair vegetation.

PA #	DISTRICT	SITE	NO.	RESPONSIBLE PARTY	CONDITION DESCRIPTION & RECOMMENDATIONS
25-219	Austin	SE SW Sec. 27	7-17	AMRB	Noxious weeds.
25-060	Marysville	Allegheny	2-2	--	Need hazard signs installed.
25-076	Marysville	Drumlummon	10-19	AMRB	Noxious weeds.
25-077	Marysville	Earthquake	40-36	--	Minor subsidence. Monitor site for further settlement.
25-015	Marysville	Empire	12-43	Landowner	Mine timbers have been vandalized and access gained around adit gate.
25-182	Marysville	Larson	19-50	--	Bullet holes in hazard sign.
25-080	Marysville	North Star	3-21	AMRB	Noxious weeds.
25-170	Marysville	NW NE Sec. 27	22-53	Landowner	Portal timbers have been vandalized and access gained from above and behind adit gate.
25-135	Marysville	Robert Emmet	25-63	--	Need hazard signs installed.
25-181	Marysville	Strawberry	17-93	--	Minor subsidence. Monitor site for further settlement.

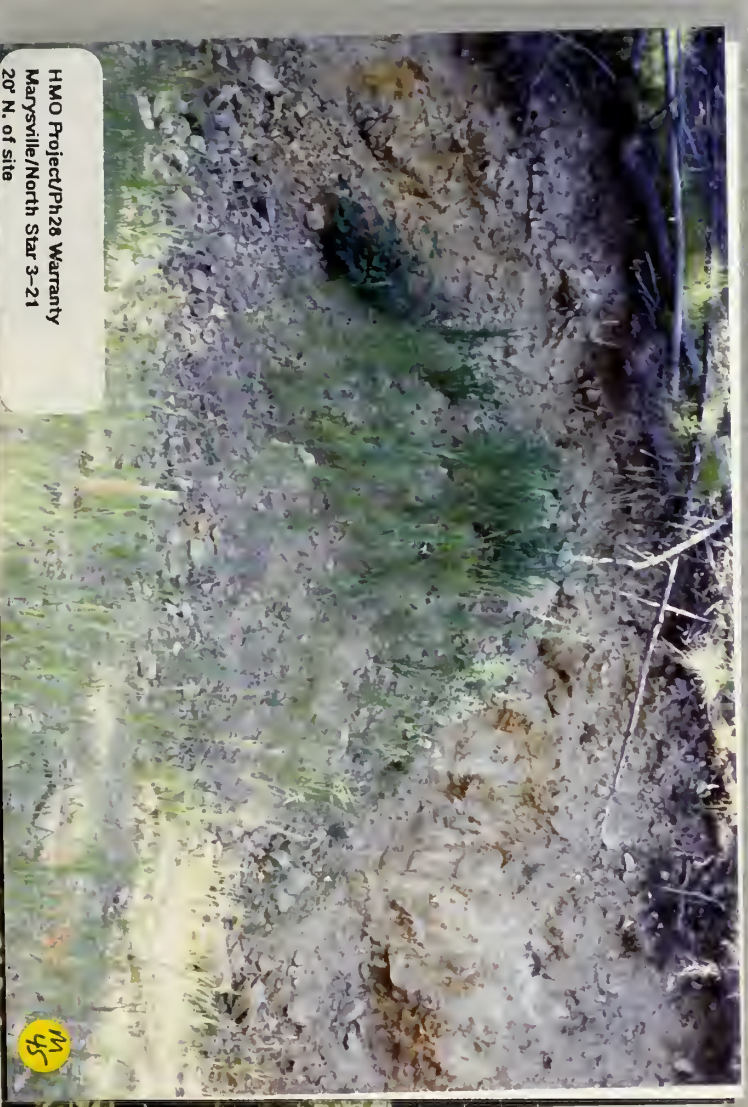
HMO Project/Ph28 Warranty  
Marysville/North Star 3-21  
20' N. of site

PA #	SITE NAME	NO.	CLOSURE	CONDITION	PHOTO NO.	COMMENTS
25-138	Nine Hour	16-59 16-60	Fence	Good	M-44	
25-080	North Star	3-21	Backfill	Good	M-45	Good vegetation. Some knapweed in area.
		3-22	Backfill	Good	M-46	Excellent vegetation.
		3-23	Backfill	Good	M-47	Excellent vegetation.
		3-24	Backfill	Good	M-48	Excellent vegetation.
		3-25	Fence	Good	M-49	
25-318	Old Empire	23-61	Backfill	Good	M-50	Excellent vegetation.
		23-62	Backfill	Good	M-51	Excellent vegetation.
25-350	Point Hope	35-34	3' Culvert	Good	M-52	Excellent vegetation.
25-135	Robert Emmet	25-63	Fence	Good	M-53	Needs hazard signs installed.
		25-64	3' Culvert	Good	M-54	Excellent vegetation.
		25-65	Culvert	Good	M-55	Excellent vegetation.
25-121	Rose Bud	26-66	Backfill	Good	M-56	Good vegetation. Currently being grazed.
25-311	SE NE Sec.10	45-68	Fence	Good	M-57	
		45-69	Blast	Good	M-58	No vegetation.
		45-70	Fence	Good	M-59	
		45-71	Blast	Good	None	No vegetation. Site located in solid rock.

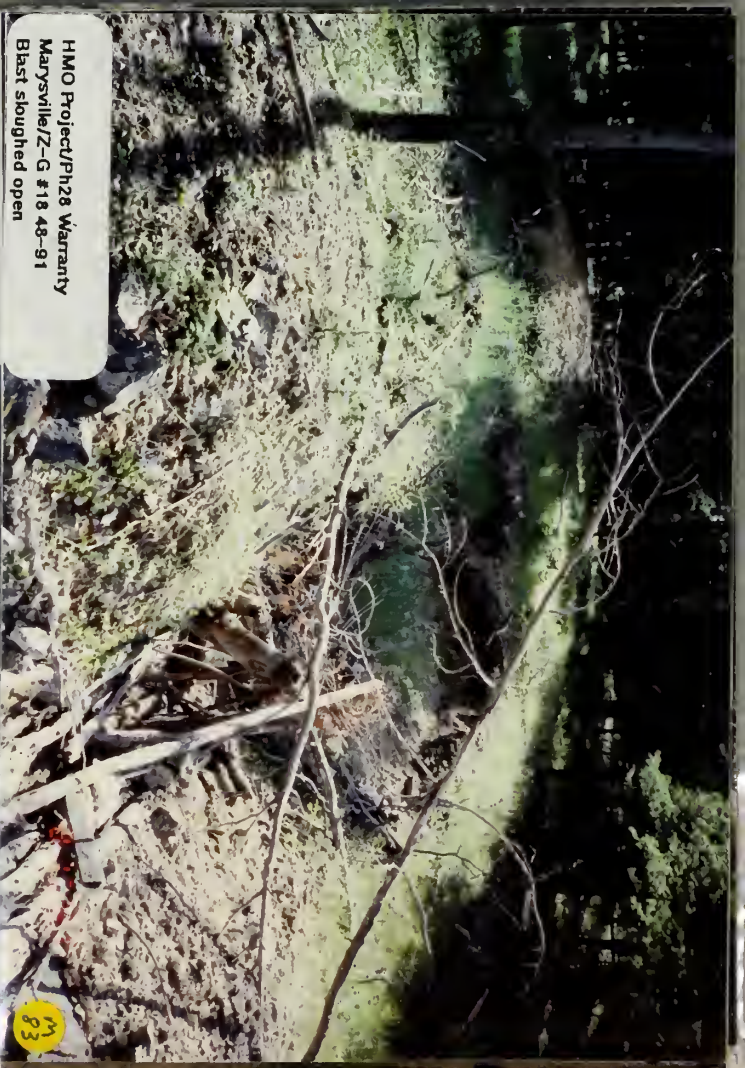
HMO Project/Ph28 Warranty  
Marysville/Z-G #18 48-91  
Blast sloughed open

48-90	Blast	Subsidence	M-83	Adit has sloughed open. Hazard not considered dangerous.
		48-67	Fence	Good	M-84
